National Emergency Management Organization
Damage Assessment and Needs Analysis

INITIAL DAMAGE ASSESSMENT REPORT

HURRICANE RICHARD
(Category 1 Storm)

Assessment Report as at 27TH OCTOBER, 2010

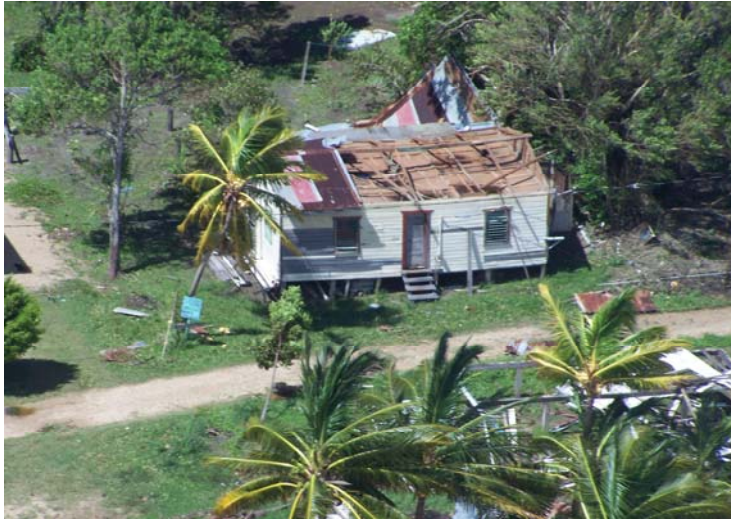
Field assessments recorded damages to structures supporting some 890 households. Damages are attributable primarily to wind force and storm surge. Of the impacted households some 570 are recorded as experienced level 1 and 2 damages to roof and wall structures and an additional 187 were severely damaged or destroyed. 134 households were disrupted as the associated storm surge deposited mud and debris into the dwellings. Table 2 below summarizes the damage to homes by District. A detailed description by communities can be found as Annex 1 of this document.

Based on reconstruction and repair estimates provided by the NEMO engineer, *losses to the housing sector is estimated as being BZD 14,137,500.*⁴ The estimated total reflects only cost for reconstruction/ repair; it does not take into consideration the cost of replacing personal household items.

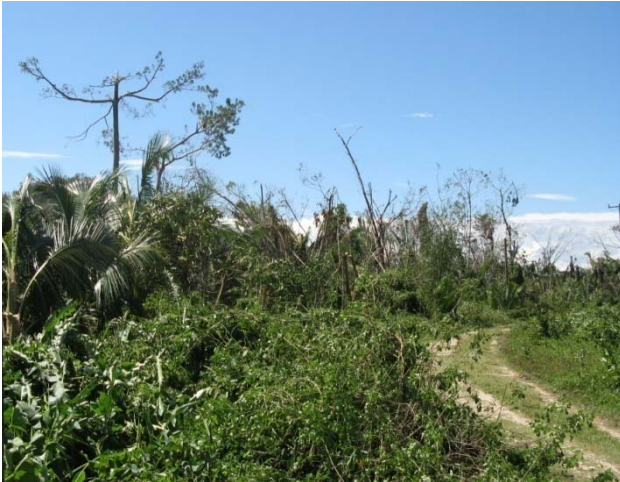
Some 600,000 acres of forests were impacted by Hurricane Richard. These forests were impacted to an average 85 miles per hour wind. An economic valuation of losses should be carried out by the Forest department.

Strong winds associated with Hurricane Richard caused significant damages to forest vegetation. The vegetation type most affected is the *Orbignya cohune* (Cohune Palm). Large stands of cohune trees blew over in the path of the storm.
